INDOOR AIR QUALITY ASSESSMENT

**Hull High School
180 Main Street
Hull, MA 02045**

Prepared by:
Massachusetts Department of Public Health
Center for Environmental Health
Emergency Response/Indoor Air Quality Program
March 2007

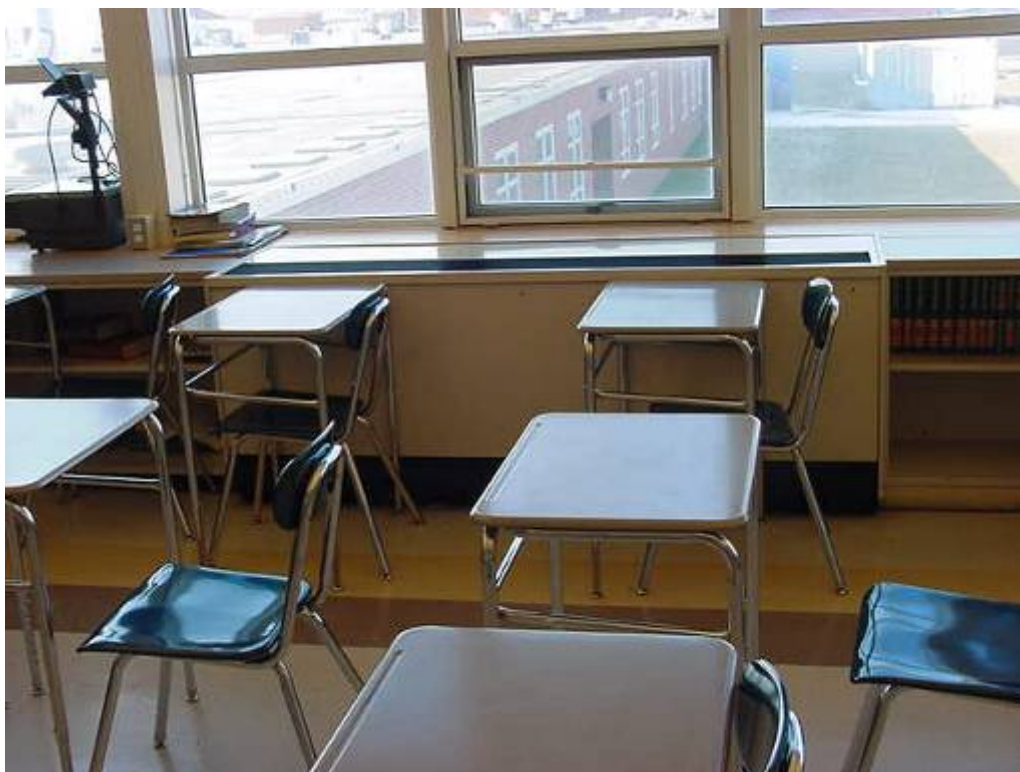
Picture 1

Fresh air in classrooms is supplied by unit ventilator (univent) systems (Picture 1). A univent draws air from the outdoors through a fresh air intake located on the exterior wall of the building (Picture 2) and returns air through an air intake located at the base of the unit. Fresh and return air are mixed, filtered, heated and provided to classrooms through an air diffuser located in the top of the unit. Adjustable louvers control the ratio of outside to recirculated air ([Figure 1](#)). Univents were found deactivated in a few areas (Table 1). Obstructions to airflow, such as items stored on or in front of univents were also observed in some areas (Table 1). In order for univents to provide fresh air as designed, units must be activated while rooms are occupied and air diffusers should remain free of obstructions.

Classroom Univent

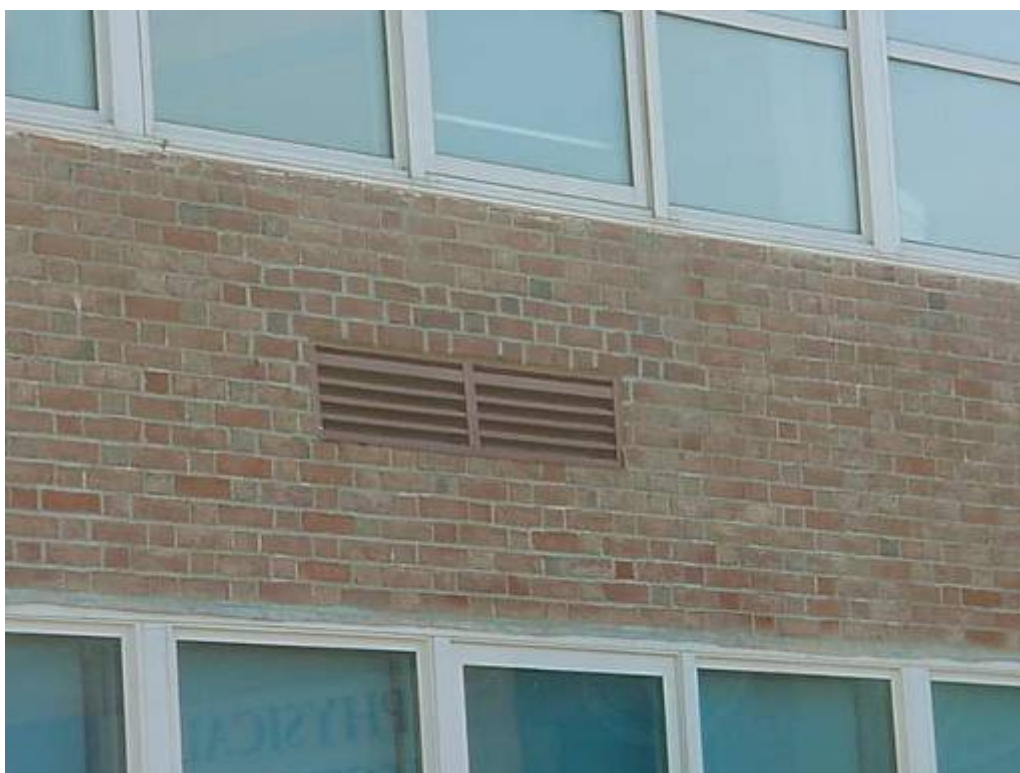
Picture 2

Univent Fresh Air Intake

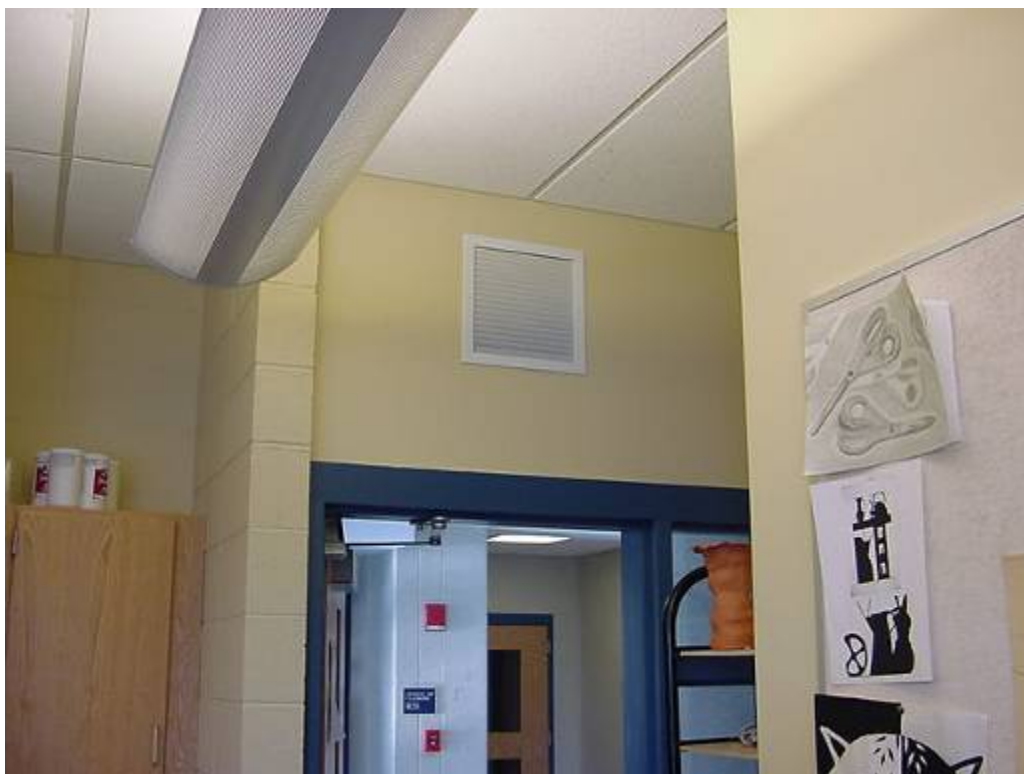
Picture 3

Exhaust ventilation in classrooms is provided by wall-mounted vents (Picture 3) ducted to rooftop motors (Picture 4). These exhausts were operating during the assessment. It is important to note that the location of some exhaust vents can limit exhaust efficiency. In some classrooms, exhaust vents are located above hallway doors (Picture 3). When classroom doors are open, exhaust vents tend to draw air from the

hallway, thereby reducing the effectiveness of the vents to remove common environmental pollutants from classrooms.

Wall-Mounted Classroom Exhaust Vent over Door

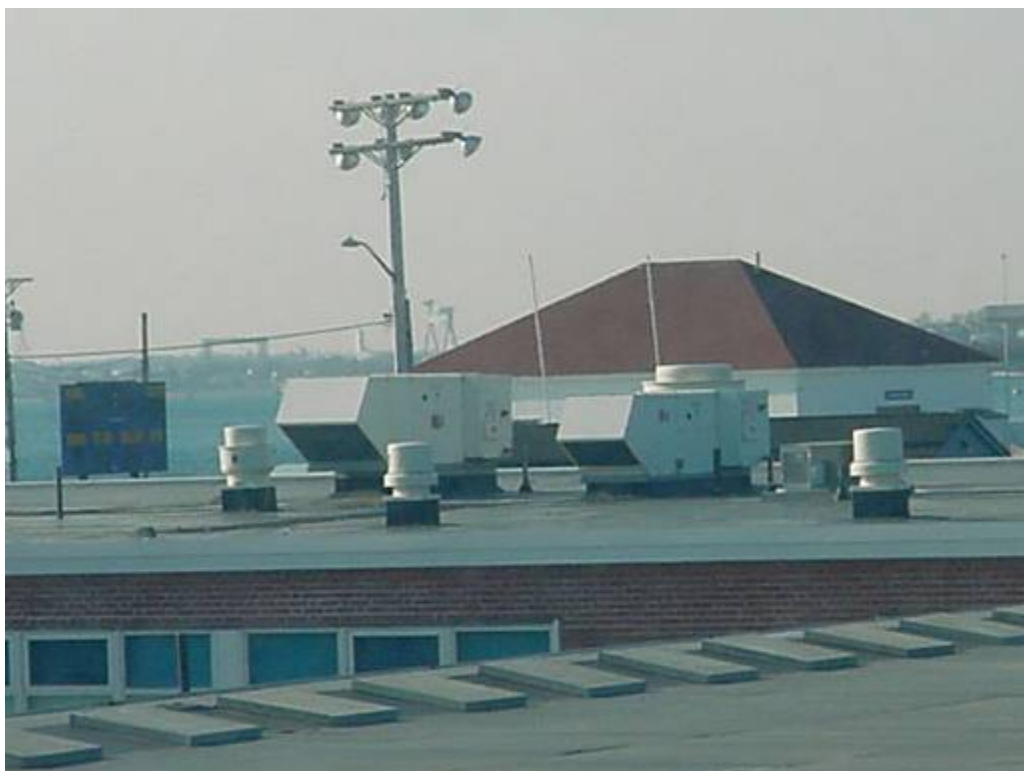
Picture 4

Mechanical ventilation in common areas and interior rooms (e.g., gym, cafeteria, media center) is provided by air handling units (AHUs) located on the roof (Picture 4). Outside air is heated or cooled and distributed to occupied areas via ceiling-mounted air diffusers (Picture 5) and ducted back to AHUs via ceiling-mounted return grates (Picture 6). Practice rooms in the music suite had neither mechanical ventilation nor openable windows to introduce fresh air. Carbon dioxide measurements were 1140 ppm and 1158 ppm in the practice rooms, which were each occupied by a student. Consideration should be given to providing a source of mechanical ventilation to these rooms.

Rooftop Air Handling Units and Exhaust Fans

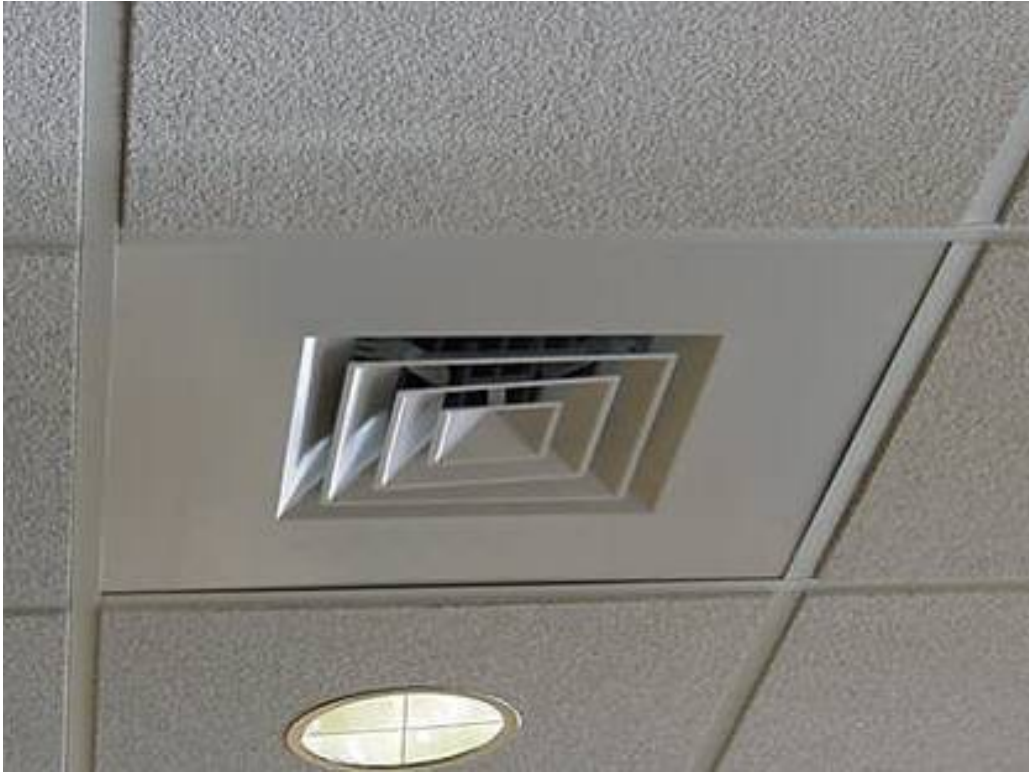
Picture 5

Ceiling-Mounted Supply Diffuser

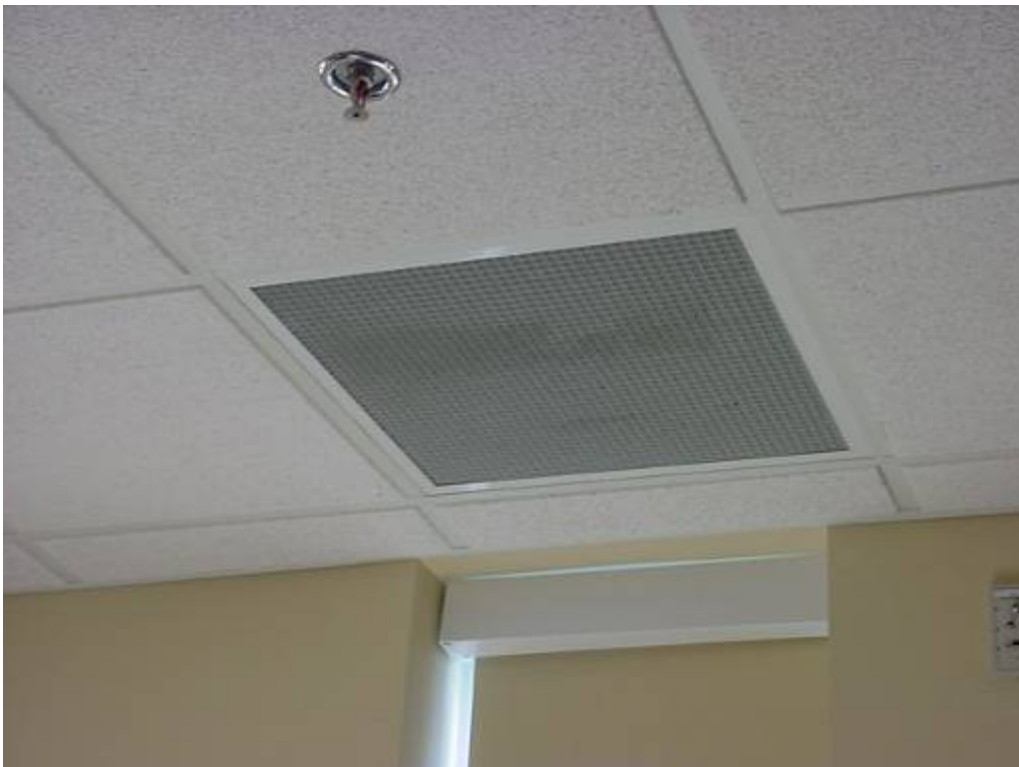
Picture 6

Ceiling-Mounted Return Vent

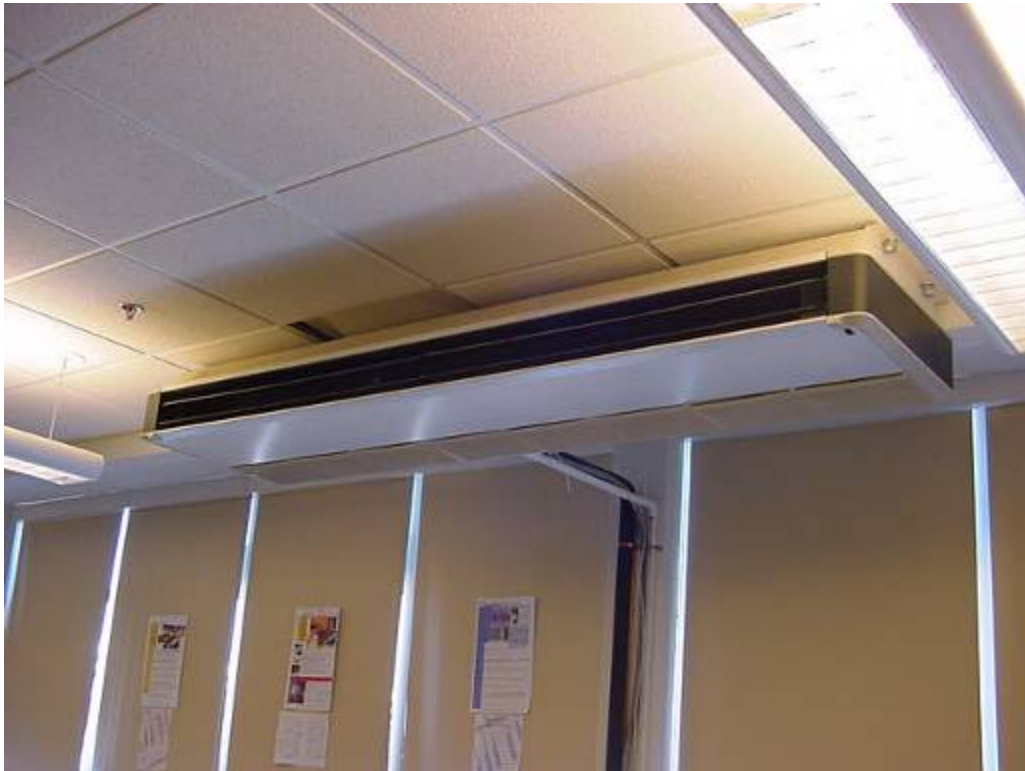
Picture 7

Temperature measurements ranged from 67° F to 76° F, which were within or close to the lower end of the MDPH recommended comfort guidelines the day of the assessment. The MDPH recommends that indoor air temperatures be maintained in a range of 70° F to 78° F in order to provide for the comfort of building occupants. In many cases concerning indoor air quality, fluctuations of temperature in occupied spaces are typically experienced, even in a building with an adequate fresh air supply. Temperature control issues were reported in the music room. A large, ceiling-mounted air conditioning unit was retro-fitted

in the music room (Picture 7). This air conditioner reportedly provides uneven cooling. CEH staff activated the unit during the assessment and observed that cooling across the coils appeared uneven, which may indicate a malfunction.

Ceiling-Mounted AC Unit in Music Room

6. Examine ceiling-mounted AC unit in music room for proper operation. Perform repairs as needed.
7. Consider adopting a balancing schedule of every 5 years for all mechanical ventilation systems, as recommended by ventilation industrial standards (SMACNA, 1994).

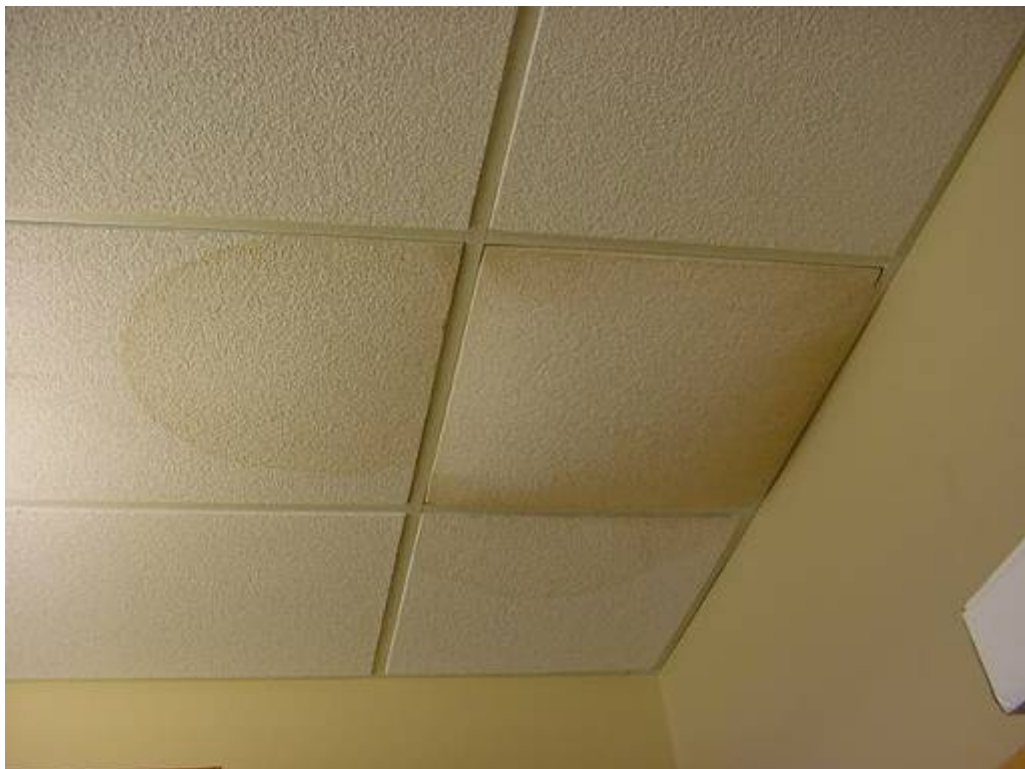
Picture 8

Water-damaged ceiling tiles were observed in several areas (Picture 8/Table 1), which can indicate leaks from the roof or plumbing system. Occupants in room B-212 reported active leaks during heavy wind-driven rain. Water-damaged ceiling tiles can provide a source for mold growth and should be replaced after a water leak is discovered and repaired. Water-damaged ceiling materials, which appeared to be constructed of gypsum wallboard, were observed in the hallway near the gymnasium (Picture 9).

Water Damaged Ceiling Tiles in Room B-212

9. Isolate and repair water leaks. Repair/replace any water-damaged ceiling tiles, plaster and/or other damaged building materials. Examine above and around these areas for mold growth. Disinfect areas of water leaks with an appropriate antimicrobial. Building occupants should report any roof leaks or other signs of water penetration to school maintenance staff for remediation.

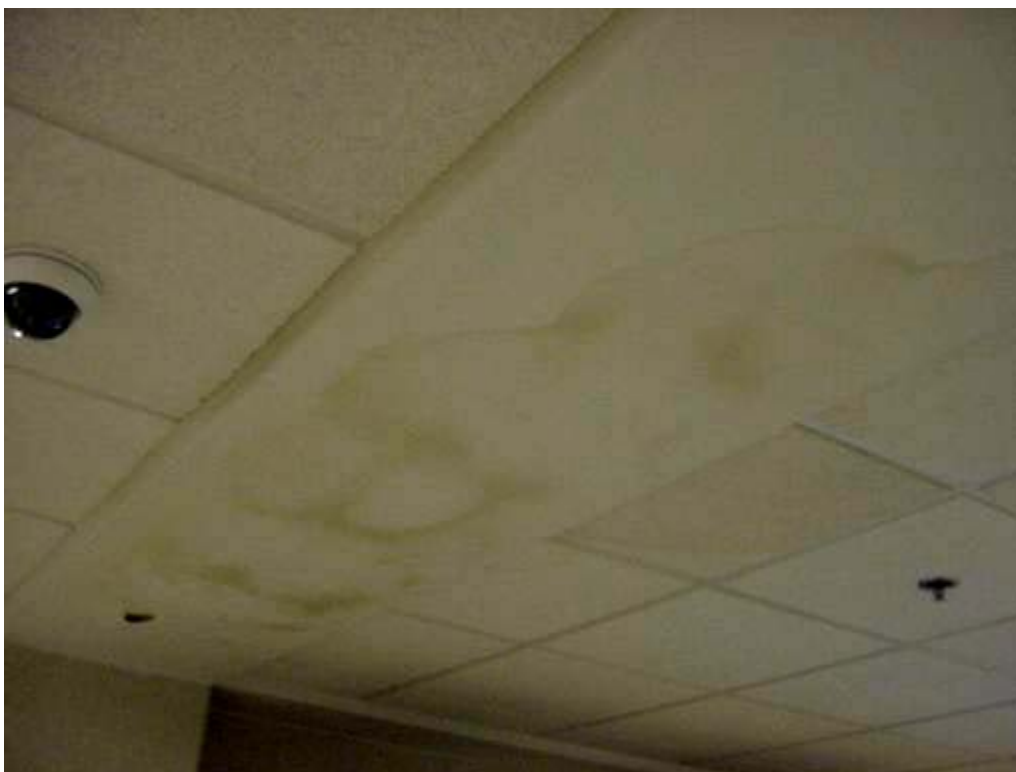
Picture 9

In an effort to ascertain moisture content of the water-damaged ceiling materials near the gymnasium, moisture content was measured with a Delmhorst Moisture Detector equipped with a Delmhorst Standard Probe. The Delmhorst probe is equipped with three lights that function as visual aids that indicate moisture level. Readings that activate the green light indicate a sufficiently dry or low moisture level, those that activate the yellow light indicate borderline conditions and those that activate the red light indicate elevated moisture content. No elevated moisture readings were measured during the assessment (Table 1).

Water Damaged Ceiling in Hallway near Gymnasium

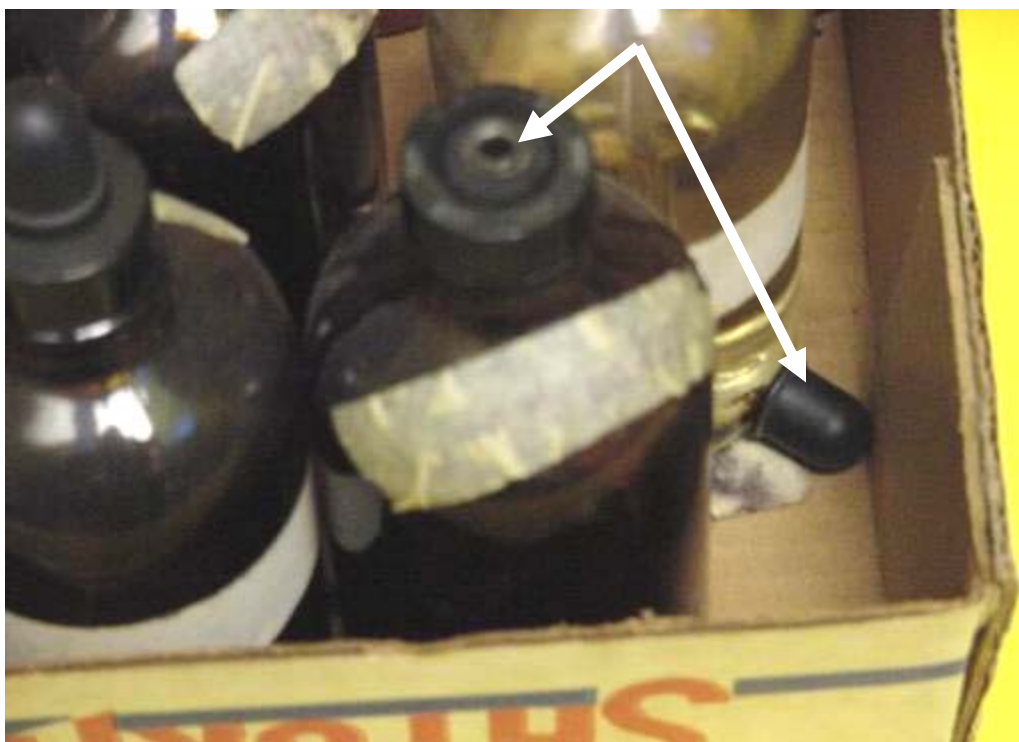
Picture 10

- Some items were labeled with chemical formula rather than by chemical name (Picture 10).

- Chemicals containers were sealed with rubber stoppers, some of which had become damaged, thereby allowing chemicals to freely off-gas (Picture 10).
- Crystallization of chemicals had occurred on the surface of some containers.
- The chemical exhaust hood in room C-115 is reportedly not operating.

Chemical Storage Containers Labeled with Chemical Formula, Also Note Damaged Rubber Stopper, Allowing the Container to Freely Off-Gas into the Chemical Storeroom

It is highly recommended that a thorough inventory of chemicals in the chemical storeroom and science department be conducted to determine whether chemical storage and disposal is conducted in an appropriate manner, consistent with Massachusetts hazardous waste laws.

12. Conduct a chemical inventory in the chemical storage room and science labs. Properly store flammable materials in a manner consistent with the local fire code. Discard hazardous materials or empty containers of hazardous materials in a manner consistent with environmental statutes and regulations. Label chemical containers with the chemical name of its contents. Follow proper procedures for storing and securing hazardous materials.
